**Flood Control Project Maintenance
Levee Inspections****LMA District Cover Sheet****Spring 2014 Levee Inspection Results****Reclamation District No. 0017 Mossdale**

Spring 2014 Levee Inspection Results

Reclamation District No. 0017 Mossdale

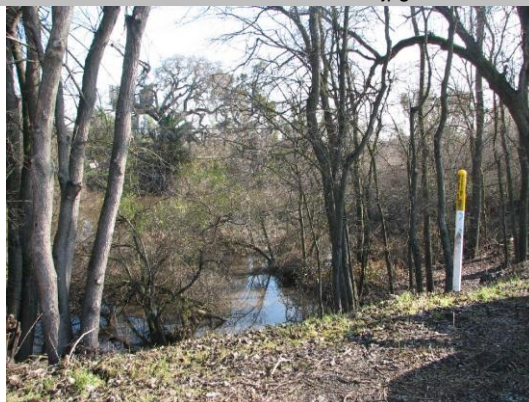
Photo 1 of 1 : UCIP_3072.jpg

LM Start	0.02	Rating **	M	Issue No.	4
LM End	0.02	Issue Type +	En	Location *	LS
Category	Supplemental			GPS Latitude/Longitude	
				Start	End
Item	DWR UCIP Field Study			37.911439 °	37.911439 °
				-121.291305 °	-121.291305 °
DWR ID	DWR_RD0017_01_s _ 2014_4				
Action/Comments					
Inspector Comments: FS_ID:22735					
EP_NO: 6623					
Repair Type:					
Crossing Status:					
UCIP Comments:					
FIELD_STRUCT_DESC: 5-inch diameter welded steel natural gas					
pipeline through the levees, 4.5 feet below the crown, across the					
channels and overflow area. (Permit No. 6623-1969)					
FS Date: 2/3/2010

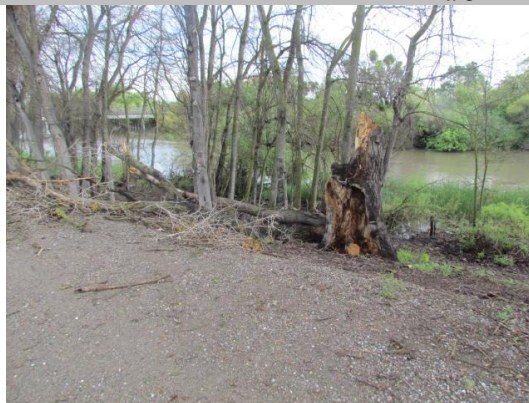
Photo 1 of 2 : richard_s_20140407_508.jpg

LM Start	0.03	Rating **	U	Issue No.	12
LM End	0.03	Issue Type +	Ma	Location *	LS
Category	Earthen Levee			GPS Latitude/Longitude	
				Start	End
Item	Encroachments			37.911629 °	37.911629 °
				-121.291585 °	-121.291585 °
DWR ID	DWR_RD0017_01_s_2014_12				
Action/Comments					
Tree or limb

Looking northeast at down tree on waterward slope.

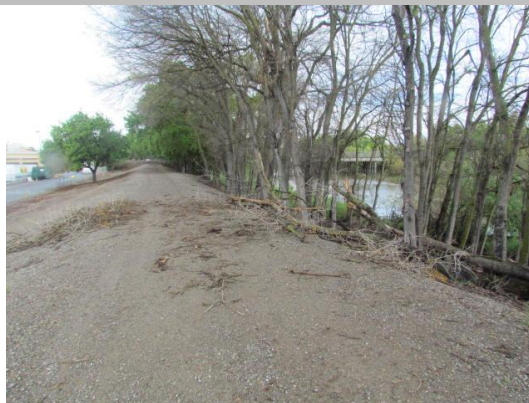
Photo 2 of 2 : richard_s_20140407_509.jpg

Looking north at tree limbs across levee crown and slope.

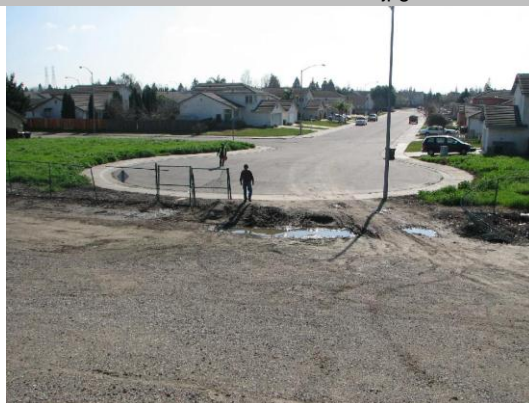
Photo 1 of 1 : UCIP_3074.jpg

LM Start	1.30	Rating **	M	Issue No.	5
LM End	1.30	Issue Type +	En	Location *	WS
Category	Supplemental			GPS Latitude/Longitude	
				Start	End
Item	DWR UCIP Field Study			37.915907 °	37.915907 °
				-121.311987 °	-121.311987 °
DWR ID	DWR_RD0017_01_s_2014_5				
Action/Comments					
Inspector Comments: FS_ID:22736					
EP_NO: 14992					
Repair Type:					
Crossing Status:					
UCIP Comments:					
FIELD_STRUCT_DESC: A 30-inch diameter HDPE sewer force main (SFM), 1 of 3 pipes, two (2) 30 inch HDPE SFMs and one (1) 12-inch diameter PVC pipe. All pipes encased in concrete at approximately 32 feet below levee crown. (Permit No. 14992-1989)					
FS Date: 2/3/2010

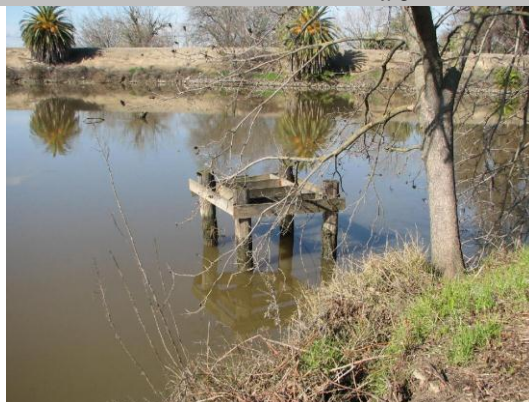
Photo 1 of 1 : UCIP_3089.jpg

LM Start	0.14	Rating **	M	Issue No.	20
LM End	0.14	Issue Type +	En	Location *	LS
Category	Supplemental			GPS Latitude/Longitude	
				Start	End
Item	DWR UCIP Field Study			37.914363 °	37.914363 °
				-121.322355 °	-121.322355 °
DWR ID	DWR_RD0017_02_s _ 2014_20				
Action/Comments					
Inspector Comments: FS_ID:22738 EP_NO: 15093 Repair Type: Crossing Status: UCIP Comments: Only appurtenance remaining at this location is the 4 pillings located on waterward side. According to records the pillings were to be removed under a completion maintenace contract. Need to coordinate with owner. FIELD_STRUCT_DESC: 14-inch-diameter pipeline through levee at unknown depth. Per inspector's notes "this crossing is abandoned almost all materials removed including pipes, conduit, and pumphouse. The only items left are 4 pilings which are to be removed under a completion maintenance contract. Approximately 200 feet of reinforced concrete pipe lateral removed in R/W south of crossing". FS Date: 2/3/2010

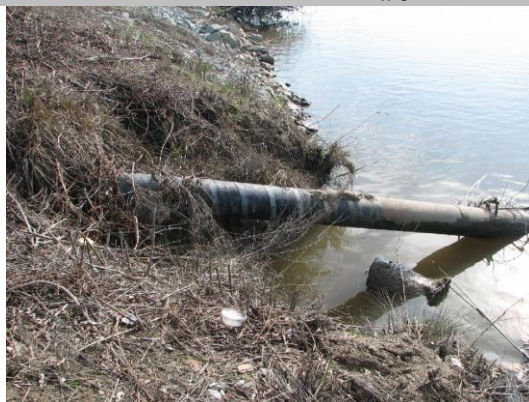
Photo 1 of 2 : UCIP_3092.jpg

LM Start	0.75	Rating **	M	Issue No.	21
LM End	0.75	Issue Type +	En	Location *	LS
Category	Supplemental			GPS Latitude/Longitude	
				Start	End
Item	DWR UCIP Field Study			37.906362 °	37.906362 °
				-121.323312 °	-121.323312 °
DWR ID	DWR_RD0017_02_s _ 2014_21				
Action/Comments					
Inspector Comments: FS_ID:22739					
EP_NO: 15095					
Repair Type:					
Crossing Status:					
UCIP Comments:					
FIELD_STRUCT_DESC: 12-inch diameter discharge pipeline through the levee. Invert of pipe is 6.24 feet below crown. Siphon breaker at the waterward shoulder. Pump located approximately 50 feet landward of the toe. (Permit No. 15095-1990)					
FS Date: 2/3/2010

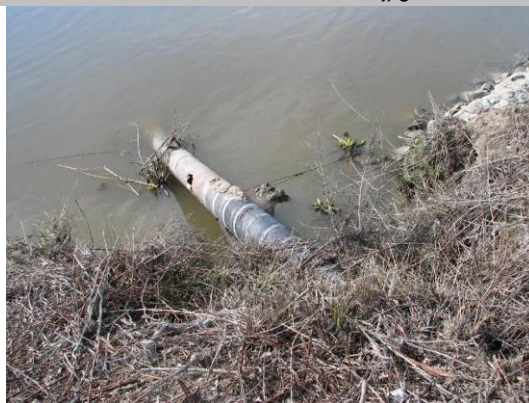
Photo 2 of 2 : UCIP_3098.jpg

LM Start	0.75	Rating **	M	Issue No.	21 (cont)	
LM End	0.75	Issue Type +	En	Location *	LS	
Category	Supplemental			GPS Latitude/Longitude		
				Start		End
Item	DWR UCIP Field Study			37.906362 °	37.906362 °	
				-121.323312 °	-121.323312 °	
DWR ID	DWR_RD0017_02_s_2014_21					
Action/Comments						
Inspector Comments: FS_ID:22739						
EP_NO: 15095						
Repair Type:						
Crossing Status:						
UCIP Comments:						
FIELD_STRUCT_DESC: 12-inch diameter discharge pipeline through the levee. Invert of pipe is 6.24 feet below crown. Siphon breaker at the waterward shoulder. Pump located approximately 50 feet landward of the toe. (Permit No. 15095-1990)						
FS Date: 2/3/2010

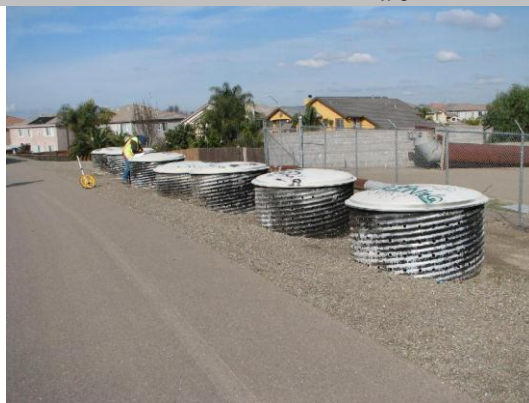
Photo 1 of 1 : UCIP_3101.jpg

LM Start	0.78	Rating **	M	Issue No.	22
LM End	0.78	Issue Type +	En	Location *	LS
Category	Supplemental			GPS Latitude/Longitude	
				Start	End
Item	DWR UCIP Field Study			37.906002 °	37.906002 °
				-121.322995 °	-121.322995 °
DWR ID	DWR_RD0017_02_s_2014_22				
Action/Comments					
Inspector Comments: FS_ID:22740 EP_NO: 15149 Repair Type: Crossing Status: UCIP Comments: FIELD_STRUCT_DESC: 2 of 8: 42 inch diameter steel pipe, six (6) 42 inch pipe and two (2) 8 inch pipes, through the levee. Reinforced concrete discharge structure located at the waterward levee toe. Siphon breakers on the landward shoulder. Pump station located landward of levee. Invert of pipelines 8.5 feet below levee crown (Permit No. 15149-1989) FS Date: 2/4/2010

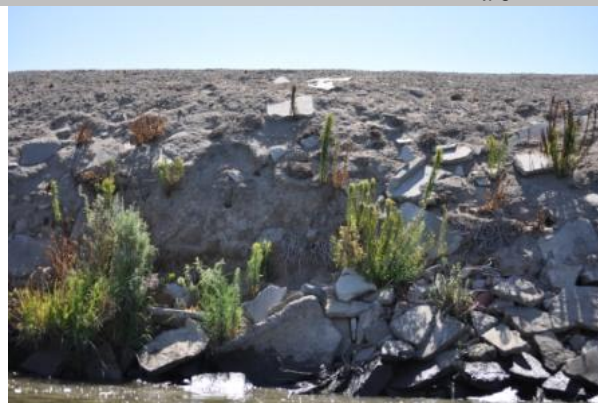
Photo 1 of 1 : richard_s_20140320_998.jpg

LM Start	1.08	Rating **	U	Issue No.	5
LM End	1.08	Issue Type +	Ma	Location *	WS
Category	Supplemental			GPS Latitude/Longitude	
				Start	End
Item	DWR Erosion Survey			37.902530 °	37.902530 °
				-121.325690 °	-121.325690 °
DWR ID	DWR_RD0017_02_s_2014_5				
Action/Comments					
Inspector Comments: 08/13/2013: No significant change at this site.

Front view of erosion site. Note the concrete blocks and vegetation.

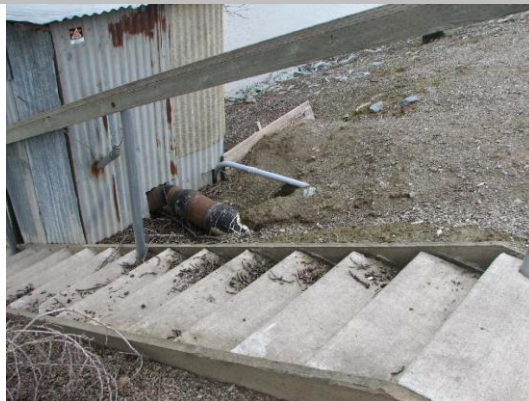
Photo 1 of 1 : UCIP_3164.jpg

LM Start	1.16	Rating **	M	Issue No.	30
LM End	1.16	Issue Type +	En	Location *	WS
Category	Supplemental			GPS Latitude/Longitude	
				Start	End
Item	DWR UCIP Field Study			37.901426 °	37.901426 °
				-121.325553 °	-121.325553 °
DWR ID	DWR_RD0017_02_s_2014_30				
Action/Comments					
Inspector Comments: FS_ID:22747					
EP_NO: 15097					
Repair Type:					
Crossing Status:					
UCIP Comments:					
FIELD_STRUCT_DESC: 8-inch diameter irrigation pipeline through levee. Invert of pipe is 4.0 feet below levee crown. Pump house is located on the waterward slope. Siphon breaker on landward shoulder, standpipe located 10 feet from landward tee. Concrete stairs on waterward slope. (Permit No. 15097-1990)					
FS Date: 2/4/2010

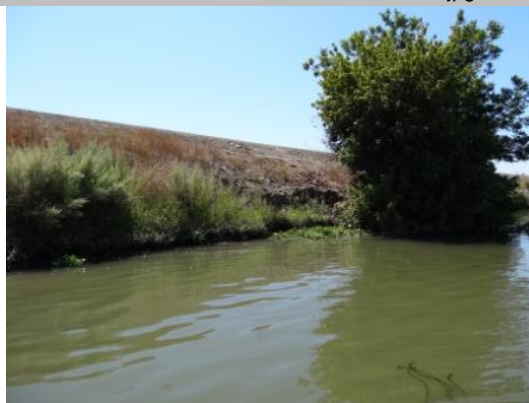
Photo 1 of 1 : richard_s_20140320_999.jpg

LM Start	1.28	Rating **	U	Issue No.	6
LM End	1.28	Issue Type +	Ma	Location *	WS
Category	Supplemental			GPS Latitude/Longitude	
				Start	End
Item	DWR Erosion Survey			37.899510 °	37.899510 °
				-121.326030 °	-121.326030 °
DWR ID	DWR_RD0017_02_s _ 2014_6				
Action/Comments					
Inspector Comments: 08/13/2013: A mid-size tree is present immediately upstream of the erosion, which could block the view of the site. Some debris is visible. [2013 Site ID:RD0017U02RM44.52]

Looking from downstream.

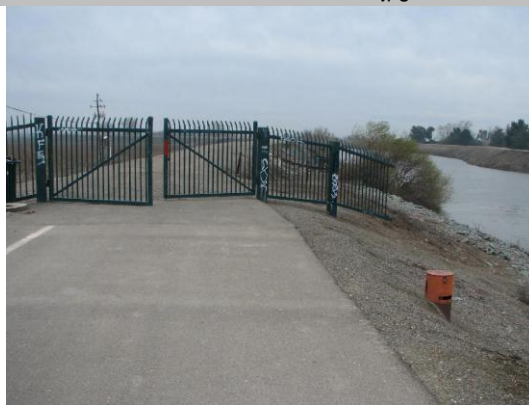
Photo 1 of 1 : UCIP_3174.jpg

LM Start	1.44	Rating **	M	Issue No.	31
LM End	1.44	Issue Type +	En	Location *	WS
Category	Supplemental			GPS Latitude/Longitude	
				Start	End
Item	DWR UCIP Field Study			37.897577 °	37.897577 °
				-121.326624 °	-121.326624 °
DWR ID	DWR_RD0017_02_s _ 2014_31				
Action/Comments					
Inspector Comments: FS_ID:22749 EP_NO: 15316 Repair Type: Crossing Status: UCIP Comments: FIELD_STRUCT_DESC: 8 inch diameter discharge pipeline through levee. Invert of pipe is 3.8 feet below levee crown. Siphon breaker on the waterward shoulder. Pump is located inside ditch located approximately 75 feet landward of levee toe. (Permit No. 15316-1989) FS Date: 2/4/2010

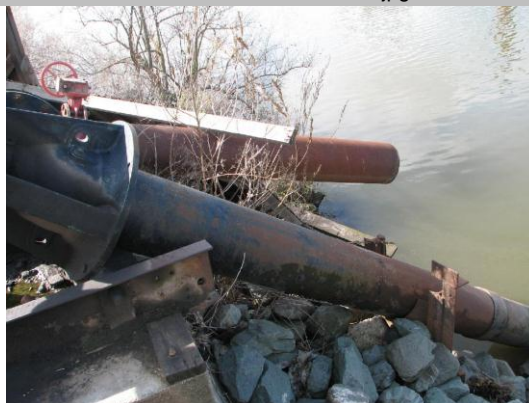
Photo 1 of 1 : UCIP_3180.jpg

LM Start	1.50	Rating **	M	Issue No.	32
LM End	1.50	Issue Type +	En	Location *	WS
Category	Supplemental			GPS Latitude/Longitude	
				Start	End
Item	DWR UCIP Field Study			37.896770 °	37.896770 °
				-121.326989 °	-121.326989 °
DWR ID	DWR_RD0017_02_s _ 2014_32				
Action/Comments					
Inspector Comments: FS_ID:22750					
EP_NO: 15099					
Repair Type:					
Crossing Status:					
UCIP Comments:					
FIELD_STRUCT_DESC: 16 inch diameter irrigation pipeline through levee. Invert of pipe is 3.64 feet below levee crown. Siphon breaker on waterward shoulder. Pump house located on the waterward berm. Standpipe located 15 feet from landward toe. Concrete stairway on waterward slope. (Permit No.15099-1989)					
FS Date: 2/4/2010

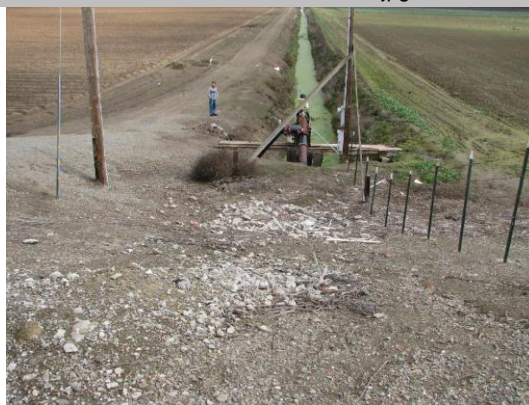
Photo 1 of 1 : UCIP_3191.jpg

LM Start	1.68	Rating **	M	Issue No.	33
LM End	1.68	Issue Type +	En	Location *	WS
Category	Supplemental			GPS Latitude/Longitude	
				Start	End
Item	DWR UCIP Field Study			37.894426 °	37.894426 °
				-121.328247 °	-121.328247 °
DWR ID	DWR_RD0017_02_s _ 2014_33				
Action/Comments					
Inspector Comments: FS_ID:22751					
EP_NO: 13729					
Repair Type:					
Crossing Status:					
UCIP Comments:					
FIELD_STRUCT_DESC: 12-inch drainage pipe through levee located approximately 3 feet below crown. (Permit No. 13729-1983)					
FS Date: 2/4/2010

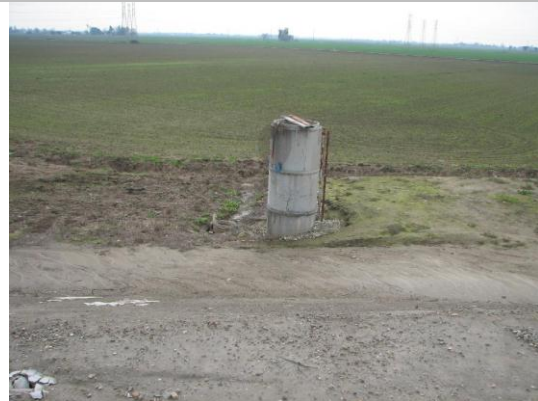
Photo 1 of 1 : UCIP_3218.jpg

LM Start	2.25	Rating **	M	Issue No.	36
LM End	2.25	Issue Type +	En	Location *	WS
Category	Supplemental			GPS Latitude/Longitude	
				Start	End
Item	DWR UCIP Field Study			37.887145 °	37.887145 °
				-121.330329 °	-121.330329 °
DWR ID	DWR_RD0017_02_s _ 2014_36				
Action/Comments					
Inspector Comments: FS_ID:22764					
EP_NO: 3013					
Repair Type:					
Crossing Status:					
UCIP Comments:					
FIELD_STRUCT_DESC: 18-inch pipe through the levee, 6.0 feet below the crown. Pump on pile structure in the stream. Timber walkway to the pump. Siphon breaker on the landward slope. Concrete standpipe at the toe of the landward slope. (Permit No. 3013-1960) This entry matches the Drainage or Irrigation Structure referenced in O&M manual (HLM 2.25). (USACE O&M, 1963).					
FS Date: 2/4/2010

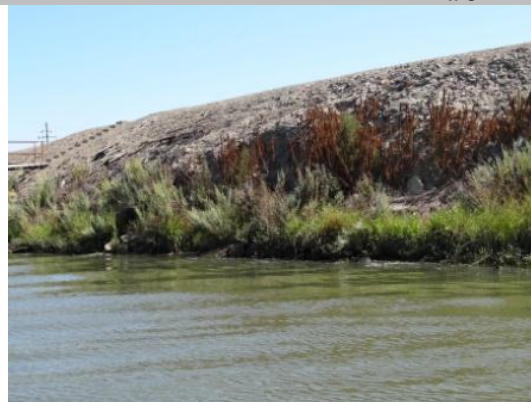
Photo 1 of 1 : richard_s_20140320_007.jpg

LM Start	2.78	Rating **	U	Issue No.	14
LM End	2.79	Issue Type +	Ma	Location *	WS
Category	Supplemental			GPS Latitude/Longitude	
				Start	End
Item	DWR Erosion Survey			37.879293 °	37.879293 °
				-121.332518 °	-121.332518 °
DWR ID	DWR_RD0017_02_s _ 2014_14				
Action/Comments					
Inspector Comments: 08/13/2013: Found during boat survey. There is vegetation at the site. [2013 Site ID:RD0017U02RM46.03]

Close view of the erosion.

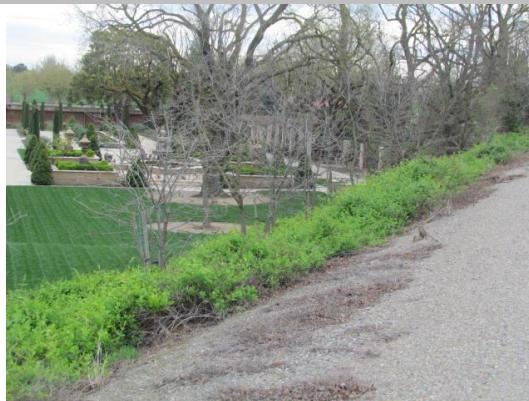
Photo 1 of 3 : richard_s_20140320_012.jpg

Looking southeast at dense ground cover on landside slope. (Spring 2013)

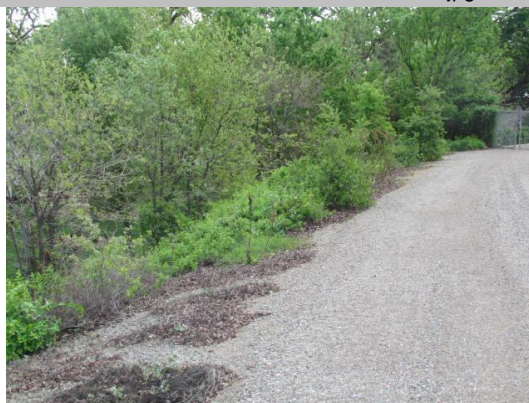
Photo 2 of 3 : richard_s_20140407_511.jpg

Looking southeast at overgrown landscaping on landside slope. (Spring 2014)

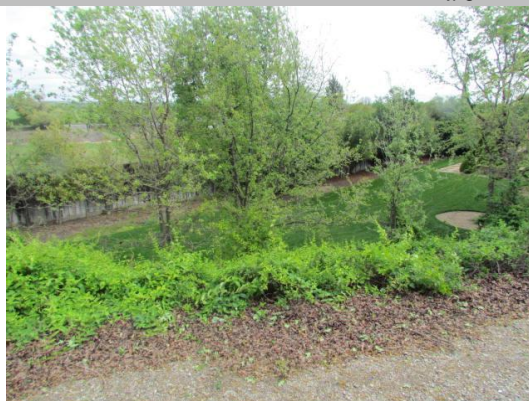
Photo 3 of 3 : richard_s_20140407_512.jpg

Looking east at overgrown landscaping on landside slope. (Spring 2014)

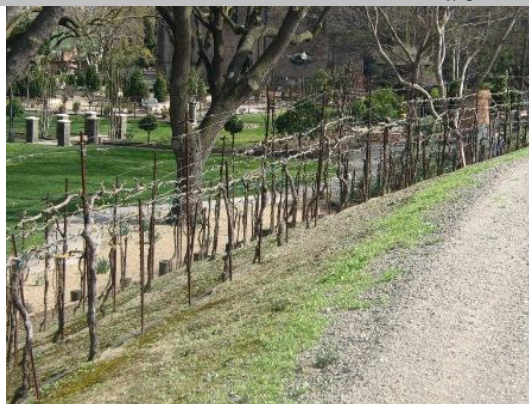
Photo 1 of 4 : richard_s_20140320_003.jpg

Grape vines on landside slope from LM 4.28 to 4.32

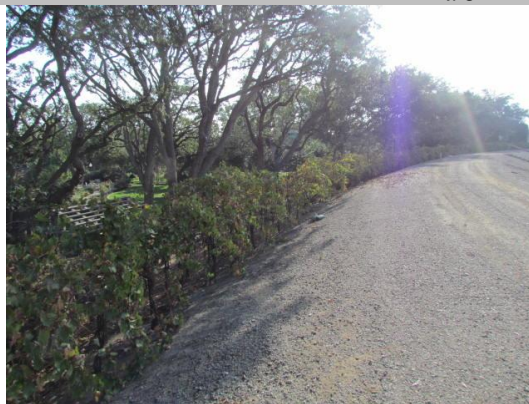
Photo 2 of 4 : richard_s_20140320_004.jpg

Looking southeast at grape vines on landside slope

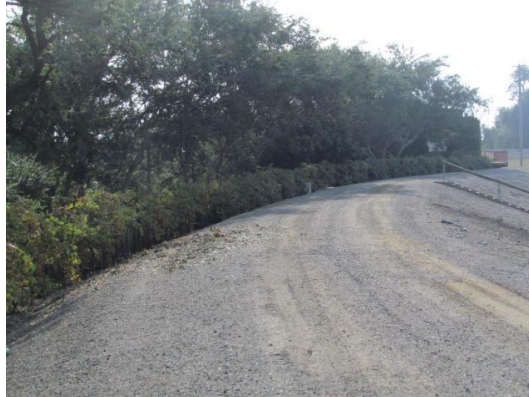
Photo 3 of 4 : richard_s_20140320_005.jpg

Looking south at landscaping with grape vines on landside slope

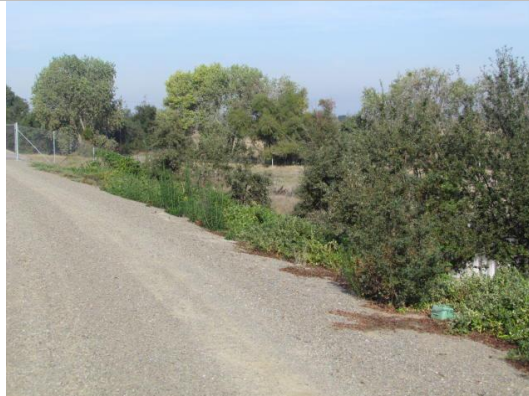
Photo 4 of 4 : richard_s_20140320_006.jpg

Looking northeast at dense landscaping on landside slope.

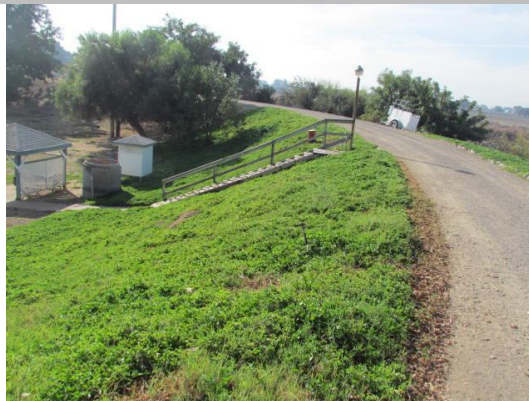
Photo 1 of 3 : richard_s_20140320_996.jpg

Looking southeast at ground cover on landside slope.

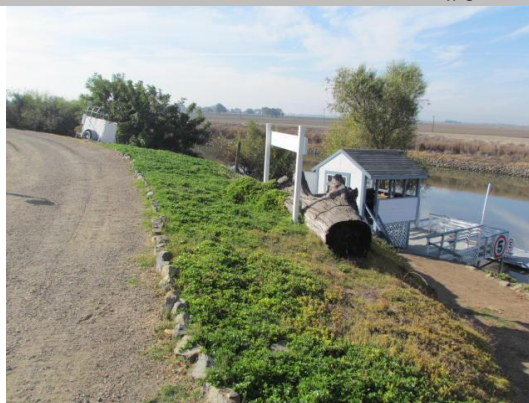
Photo 2 of 3 : richard_s_20140320_997.jpg

Looking southwest at landscaping and boat dock on waterside slope and channel.

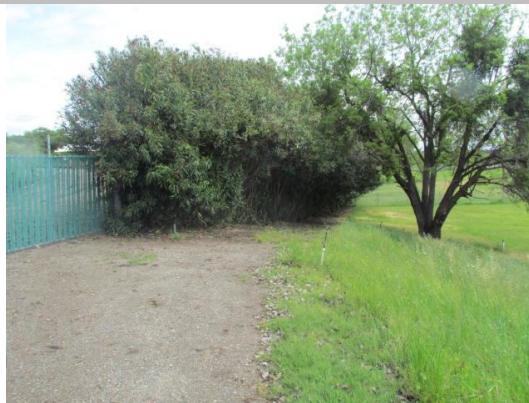
Photo 3 of 3 : richard_s_20140407_513.jpg

Looking south at overgrown oleanders on landside shoulder. (Spring 2014)

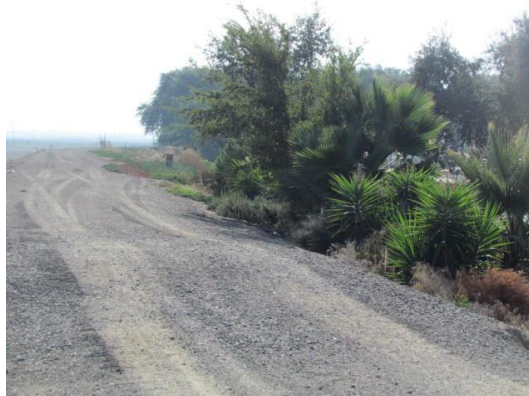
Photo 1 of 5 : richard_s_20140320_013.jpg

Looking south at overgrown landscaping on waterside slope.

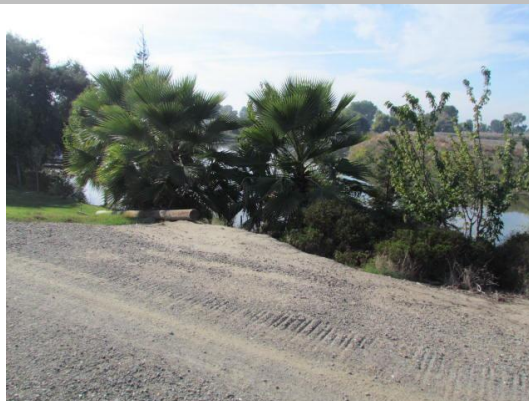
Photo 2 of 5 : richard_s_20140320_014.jpg

Looking west at landscaping on waterside slope.

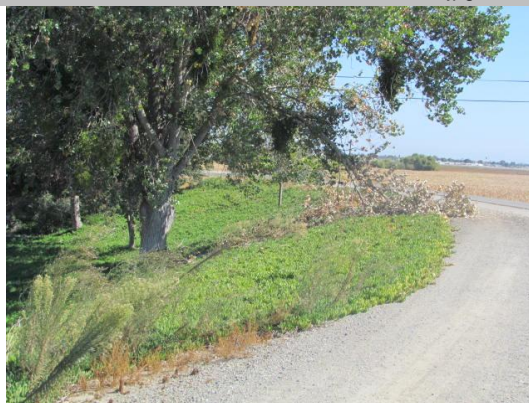
Photo 3 of 5 : richard_s_20140320_015.jpg

Looking northeast at landscaping and broken tree limb on waterward slope. 2013

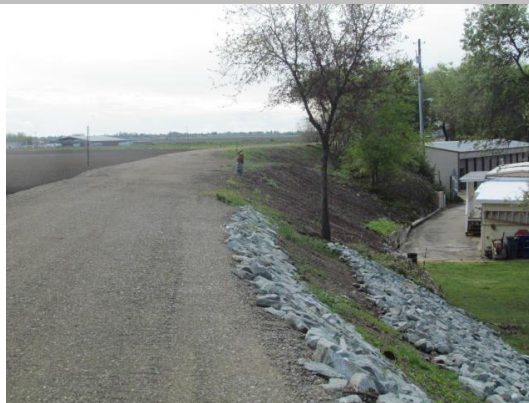
Photo 4 of 5 : richard_s_20140407_514.jpg

Looking south at corrected landscaping and the removal of a pipe on waterward slope. (Spring 2014)

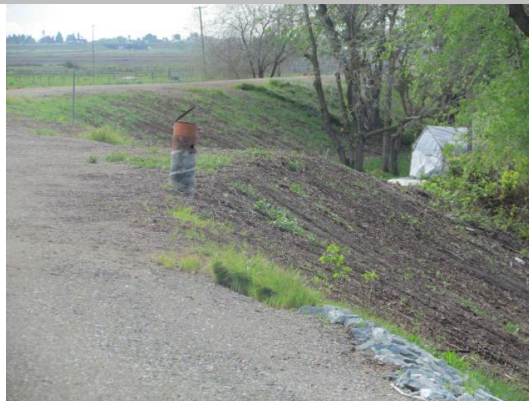
Photo 5 of 5 : richard_s_20140407_515.jpg

Looking southeast at corrected landscaping and removal of broken tree limb on waterward slope. (Spring 2014).

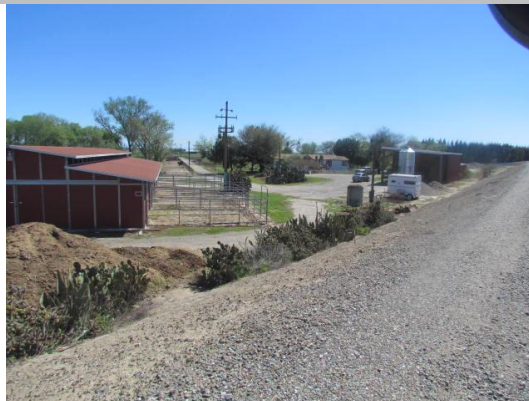
Photo 1 of 4 : richard_s_20140320_008.jpg

Looking southeast at cactus on landward toe.

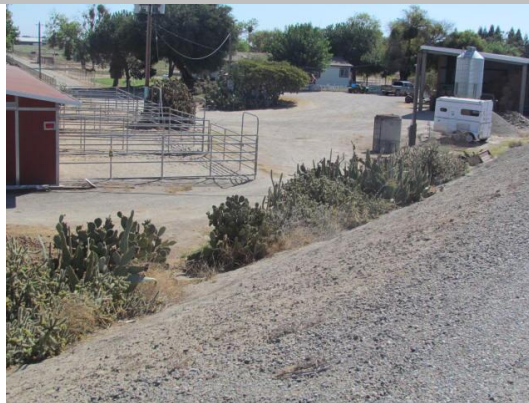
Photo 2 of 4 : richard_s_20140320_009.jpg

Looking southeast at cactus on landward toe. 2013

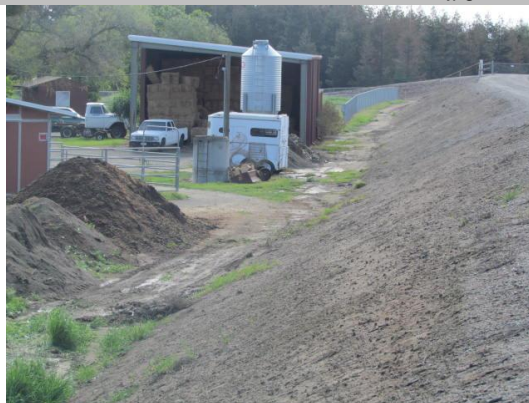
Photo 3 of 4 : richard_s_20140407_516.jpg

Looking southeast at corrected vegetation (Cactus) issue on landside toe.

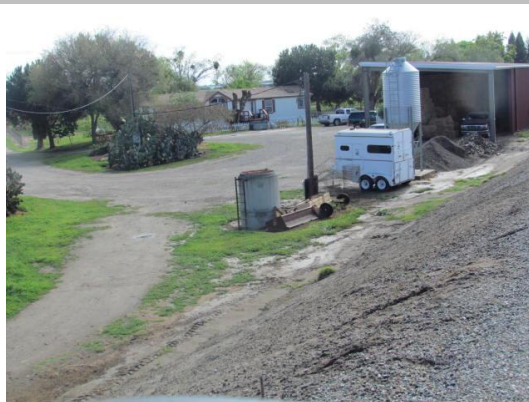
Photo 4 of 4 : richard_s_20140407_517.jpg

Looking southeast at equipment moved from landside toe.

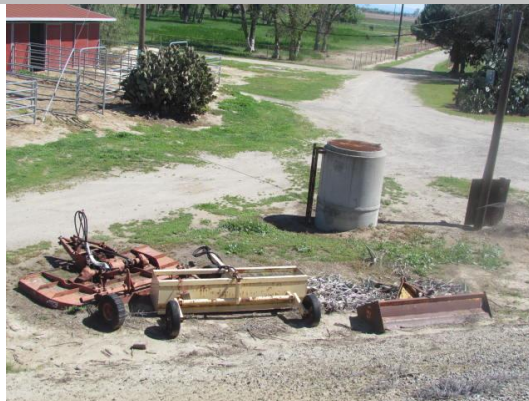
Photo 1 of 1 : richard_s_20140320_010.jpg

Looking east at farm equipment on landward toe.

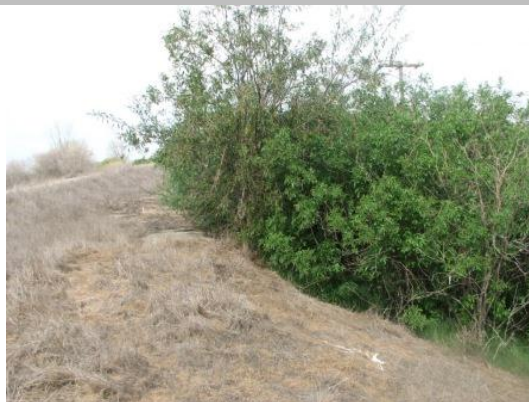
Photo 1 of 1 : richard_s_20140320_011.jpg

Elderberry blocking view of landside slope and toe from LM 7.67 to 7.69

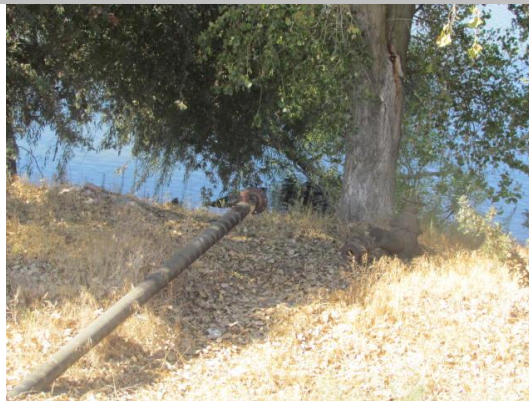
Photo 1 of 3 : richard_s_20140320_016.jpg

Looking west at disconnected pipe on waterside slope.

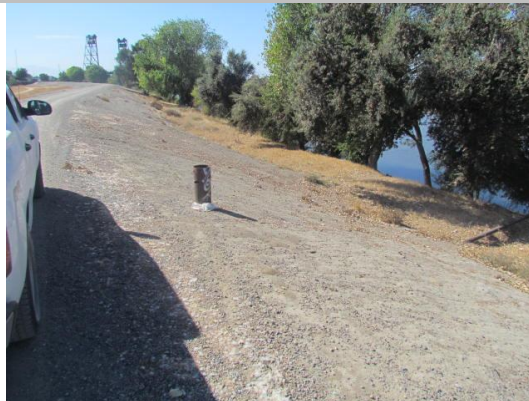
Photo 2 of 3 : richard_s_20140320_017.jpg

Looking southwest at siphon on waterside shoulder and slope.

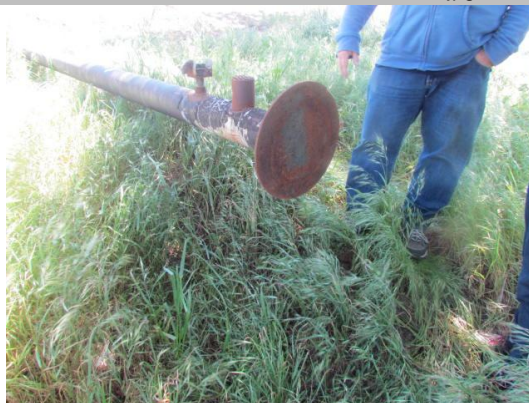
Photo 3 of 3 : richard_s_20140320_018.jpg

Looking southeast at cap on abandoned irrigation pipe on waterward slope.
